CONNECTICUT RIVER BASIN  
NORTHAMPTON, MASS.

ROBERTS MEADOW  
UPPER RESERVOIR DAM  
MA 00760

PHASE I INSPECTION REPORT  
NATIONAL DAM INSPECTION PROGRAM

JUNE 1980

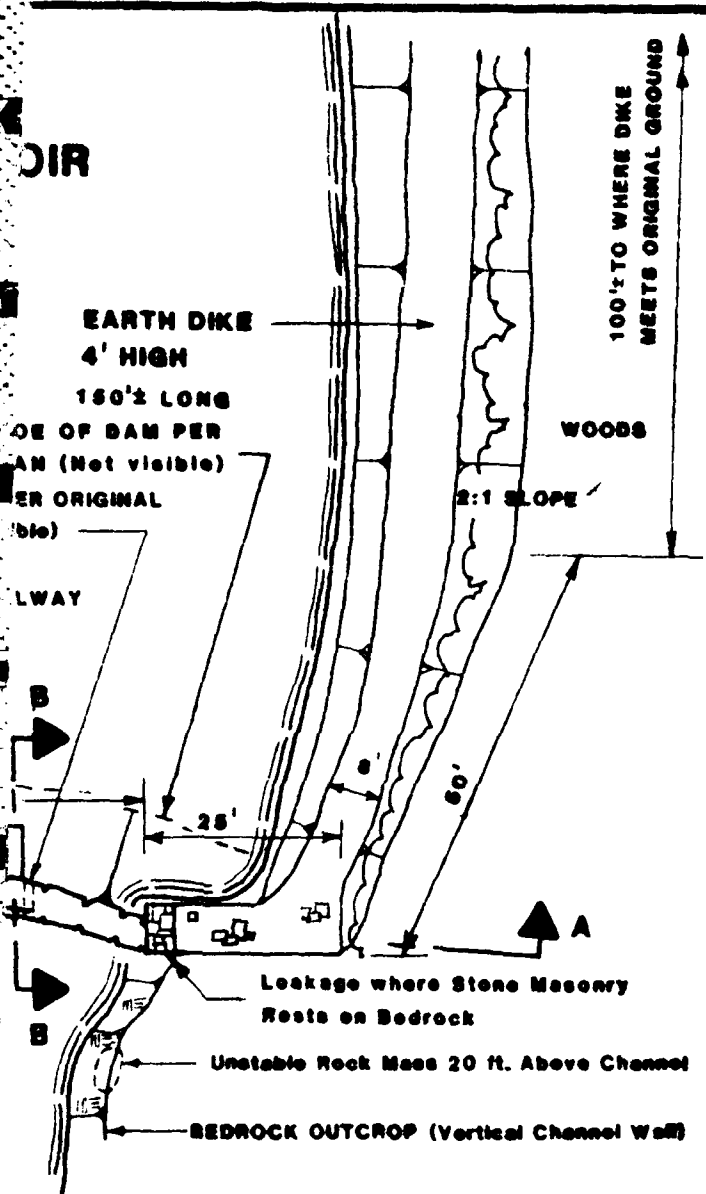
LOCATION OF FORMER TIMBER APRON (Now Destroyed)  
 REMAINS OF FORMER GATE HOUSE  
 (Stone Blocks Dislocated-Major Leakage in this Area)
